# **Point Wells Development Urban Center Submittal PFN: 11 101008LDA**

## **Targeted Stormwater Site Plan Report**

March 4, 2011  
Revised April 4, 2016  
Revised April 18, 2017  
Revision April 24, 2018  
Revision December 12, 2019

**Targeted Drainage Report**

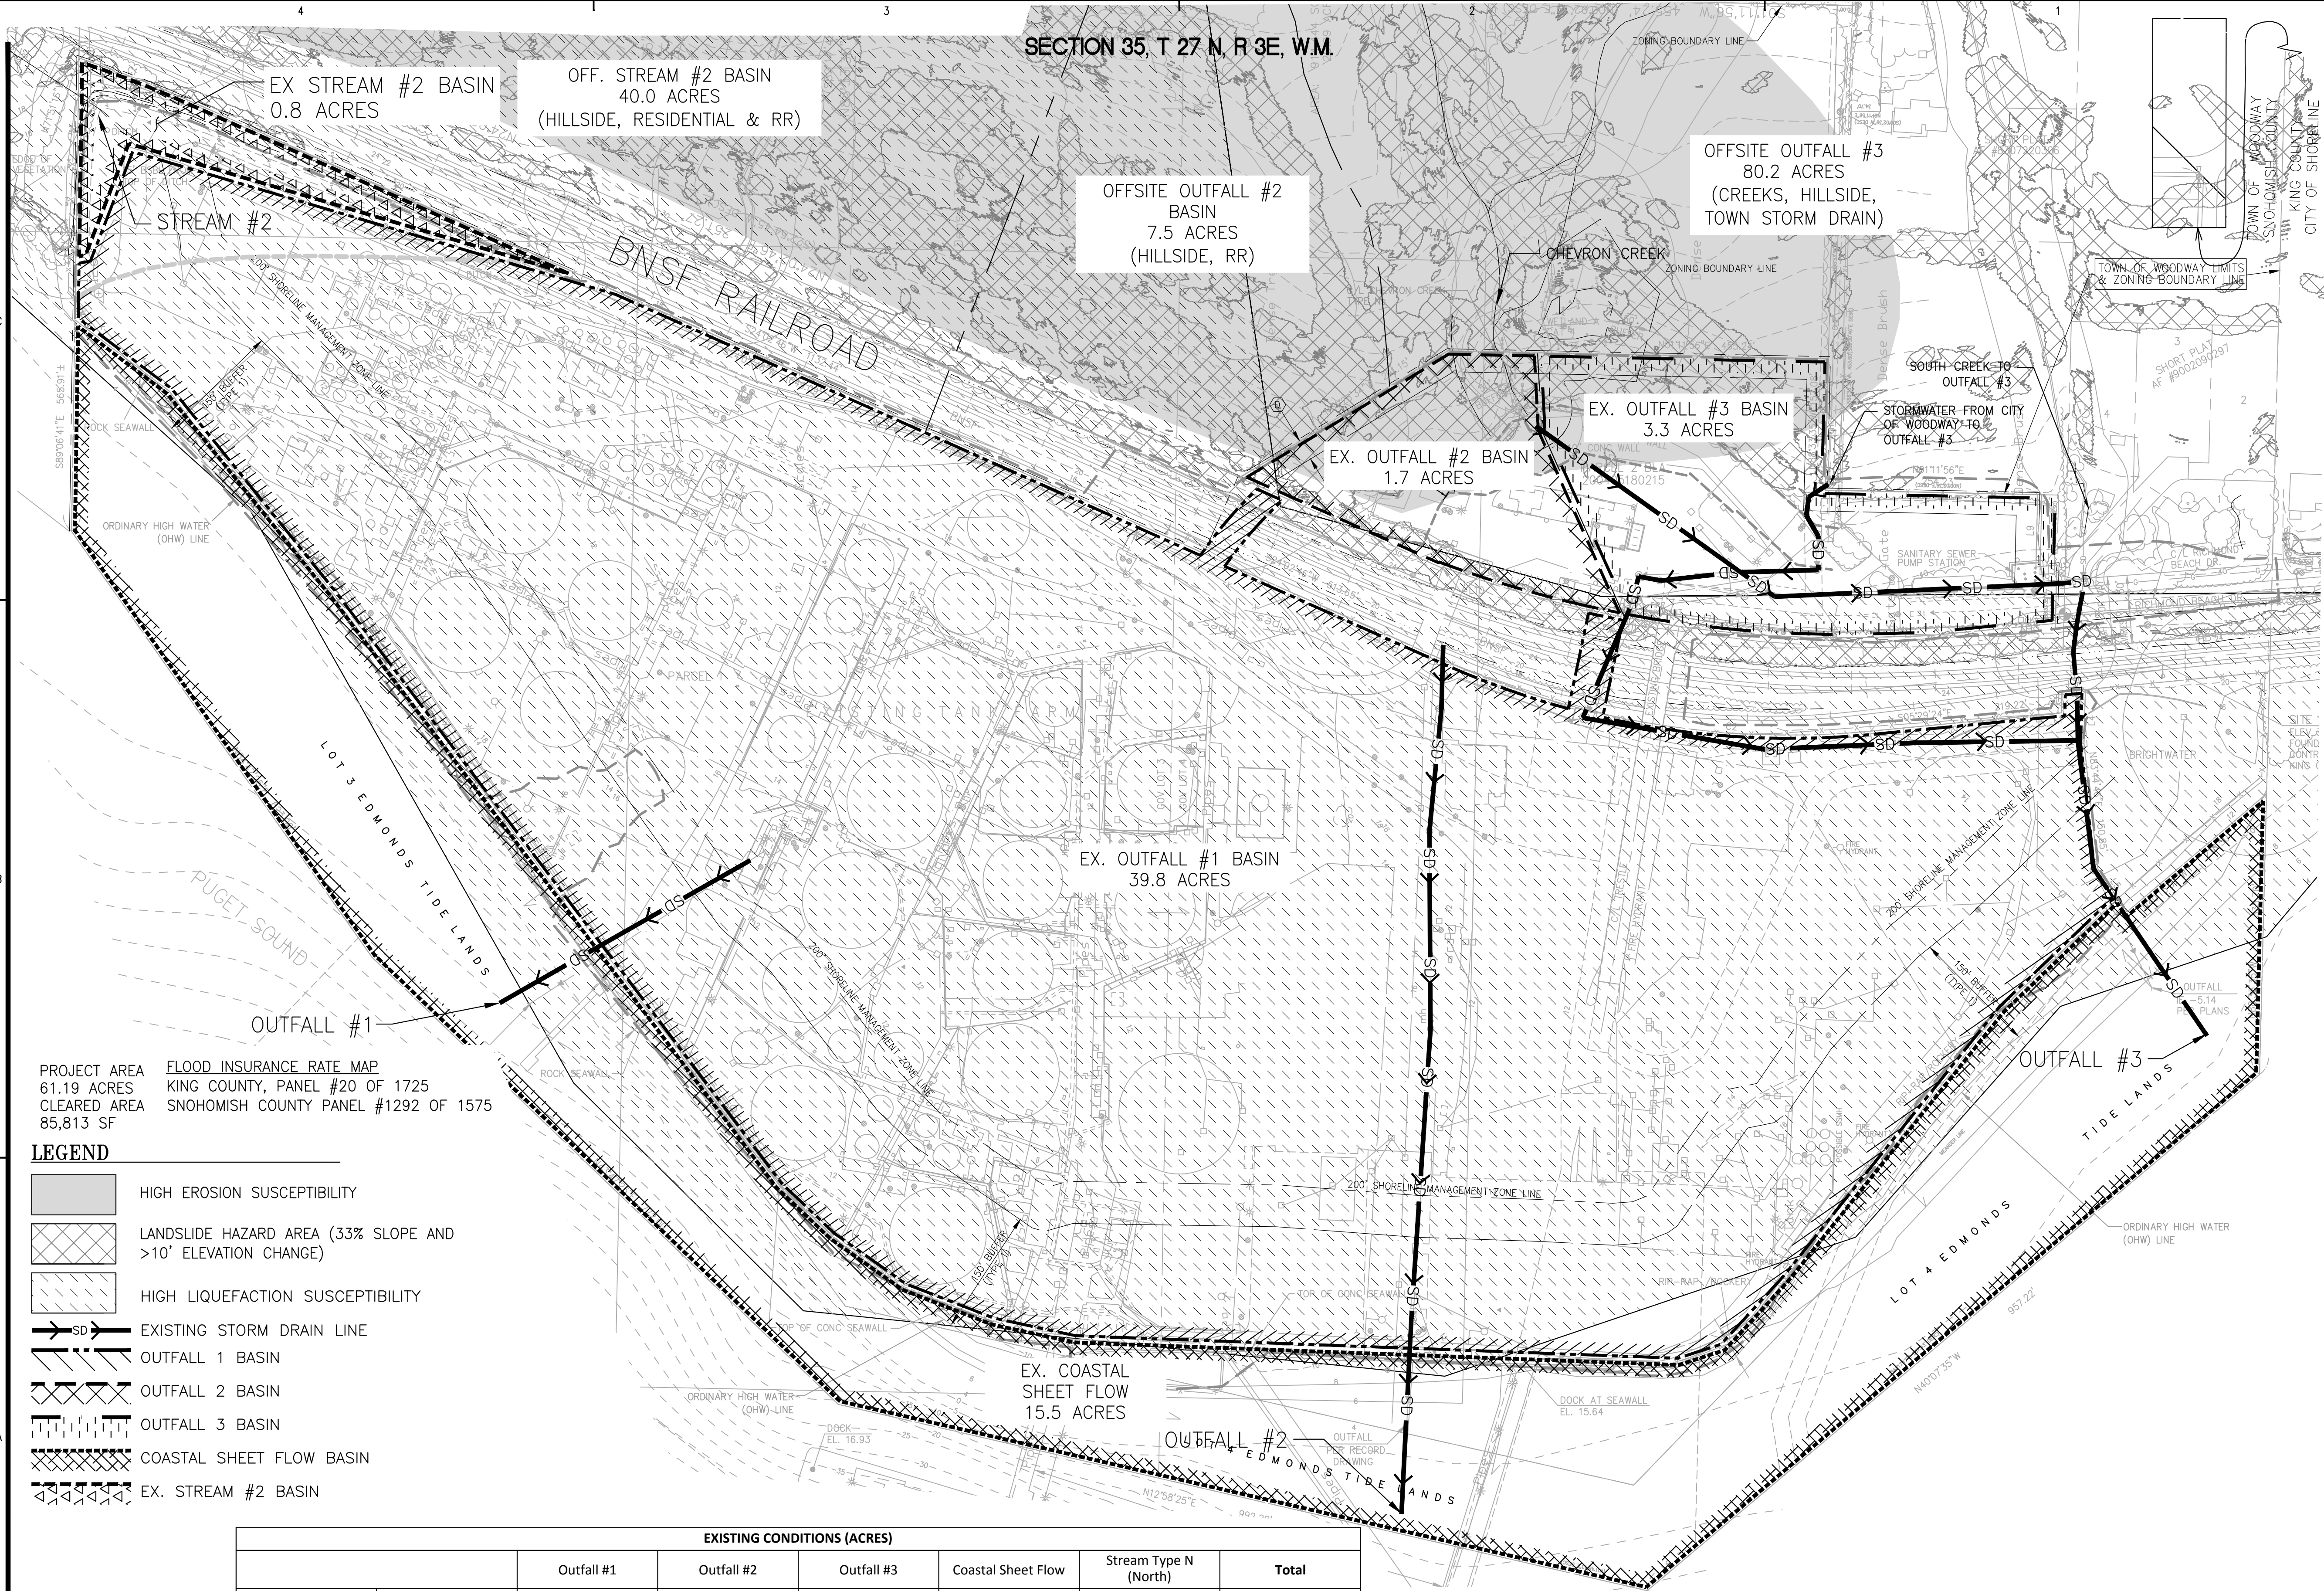
Sheet  
**C-010**  
NOT Issued for Construction  
Copyright © 2010 Perkins+Will

PROJECT AREA 61.19 ACRES  
CLEARED AREA 85,813 SF  
FLOOD INSURANCE RATE MAP  
KING COUNTY, PANEL #20 OF 1725  
SNOHOMISH COUNTY PANEL #1292 OF 1575

- LEGEND**
- HIGH EROSION SUSCEPTIBILITY
  - LANDSLIDE HAZARD AREA (33% SLOPE AND >10' ELEVATION CHANGE)
  - HIGH LIQUEFACTION SUSCEPTIBILITY
  - EXISTING STORM DRAIN LINE
  - OUTFALL 1 BASIN
  - OUTFALL 2 BASIN
  - OUTFALL 3 BASIN
  - COASTAL SHEET FLOW BASIN
  - EX. STREAM #2 BASIN

EXISTING CONDITIONS (ACRES)							
Onsite	Existing Impervious	38.71	0.18	0.85	0.00	0.38	40.12
	Existing Pervious	1.10	1.52	2.49	15.54	0.42	21.07
	Subtotal	39.81	1.70	3.34	15.54	0.80	61.19
Offsite	Existing Impervious	0	0	44.03	0	11.58	55.61
	Existing Pervious	0.00	7.50	36.173	0.00	28.42	72.09
	Subtotal	0.00	7.50	80.20	0.00	40.00	127.70
Total		39.81	9.20	83.54	15.54	40.80	188.89

The Project is in the Point Wells Drainage Basin, a sub-basin of the Snohomish County Puget Sound Drainage Basin, managed by the Snohomish County (“County”) Surface Water Management Division (SWMD). See Appendix A for an on-site drainage basin figure. A full size plan is also provided with the Urban Center Plan application.

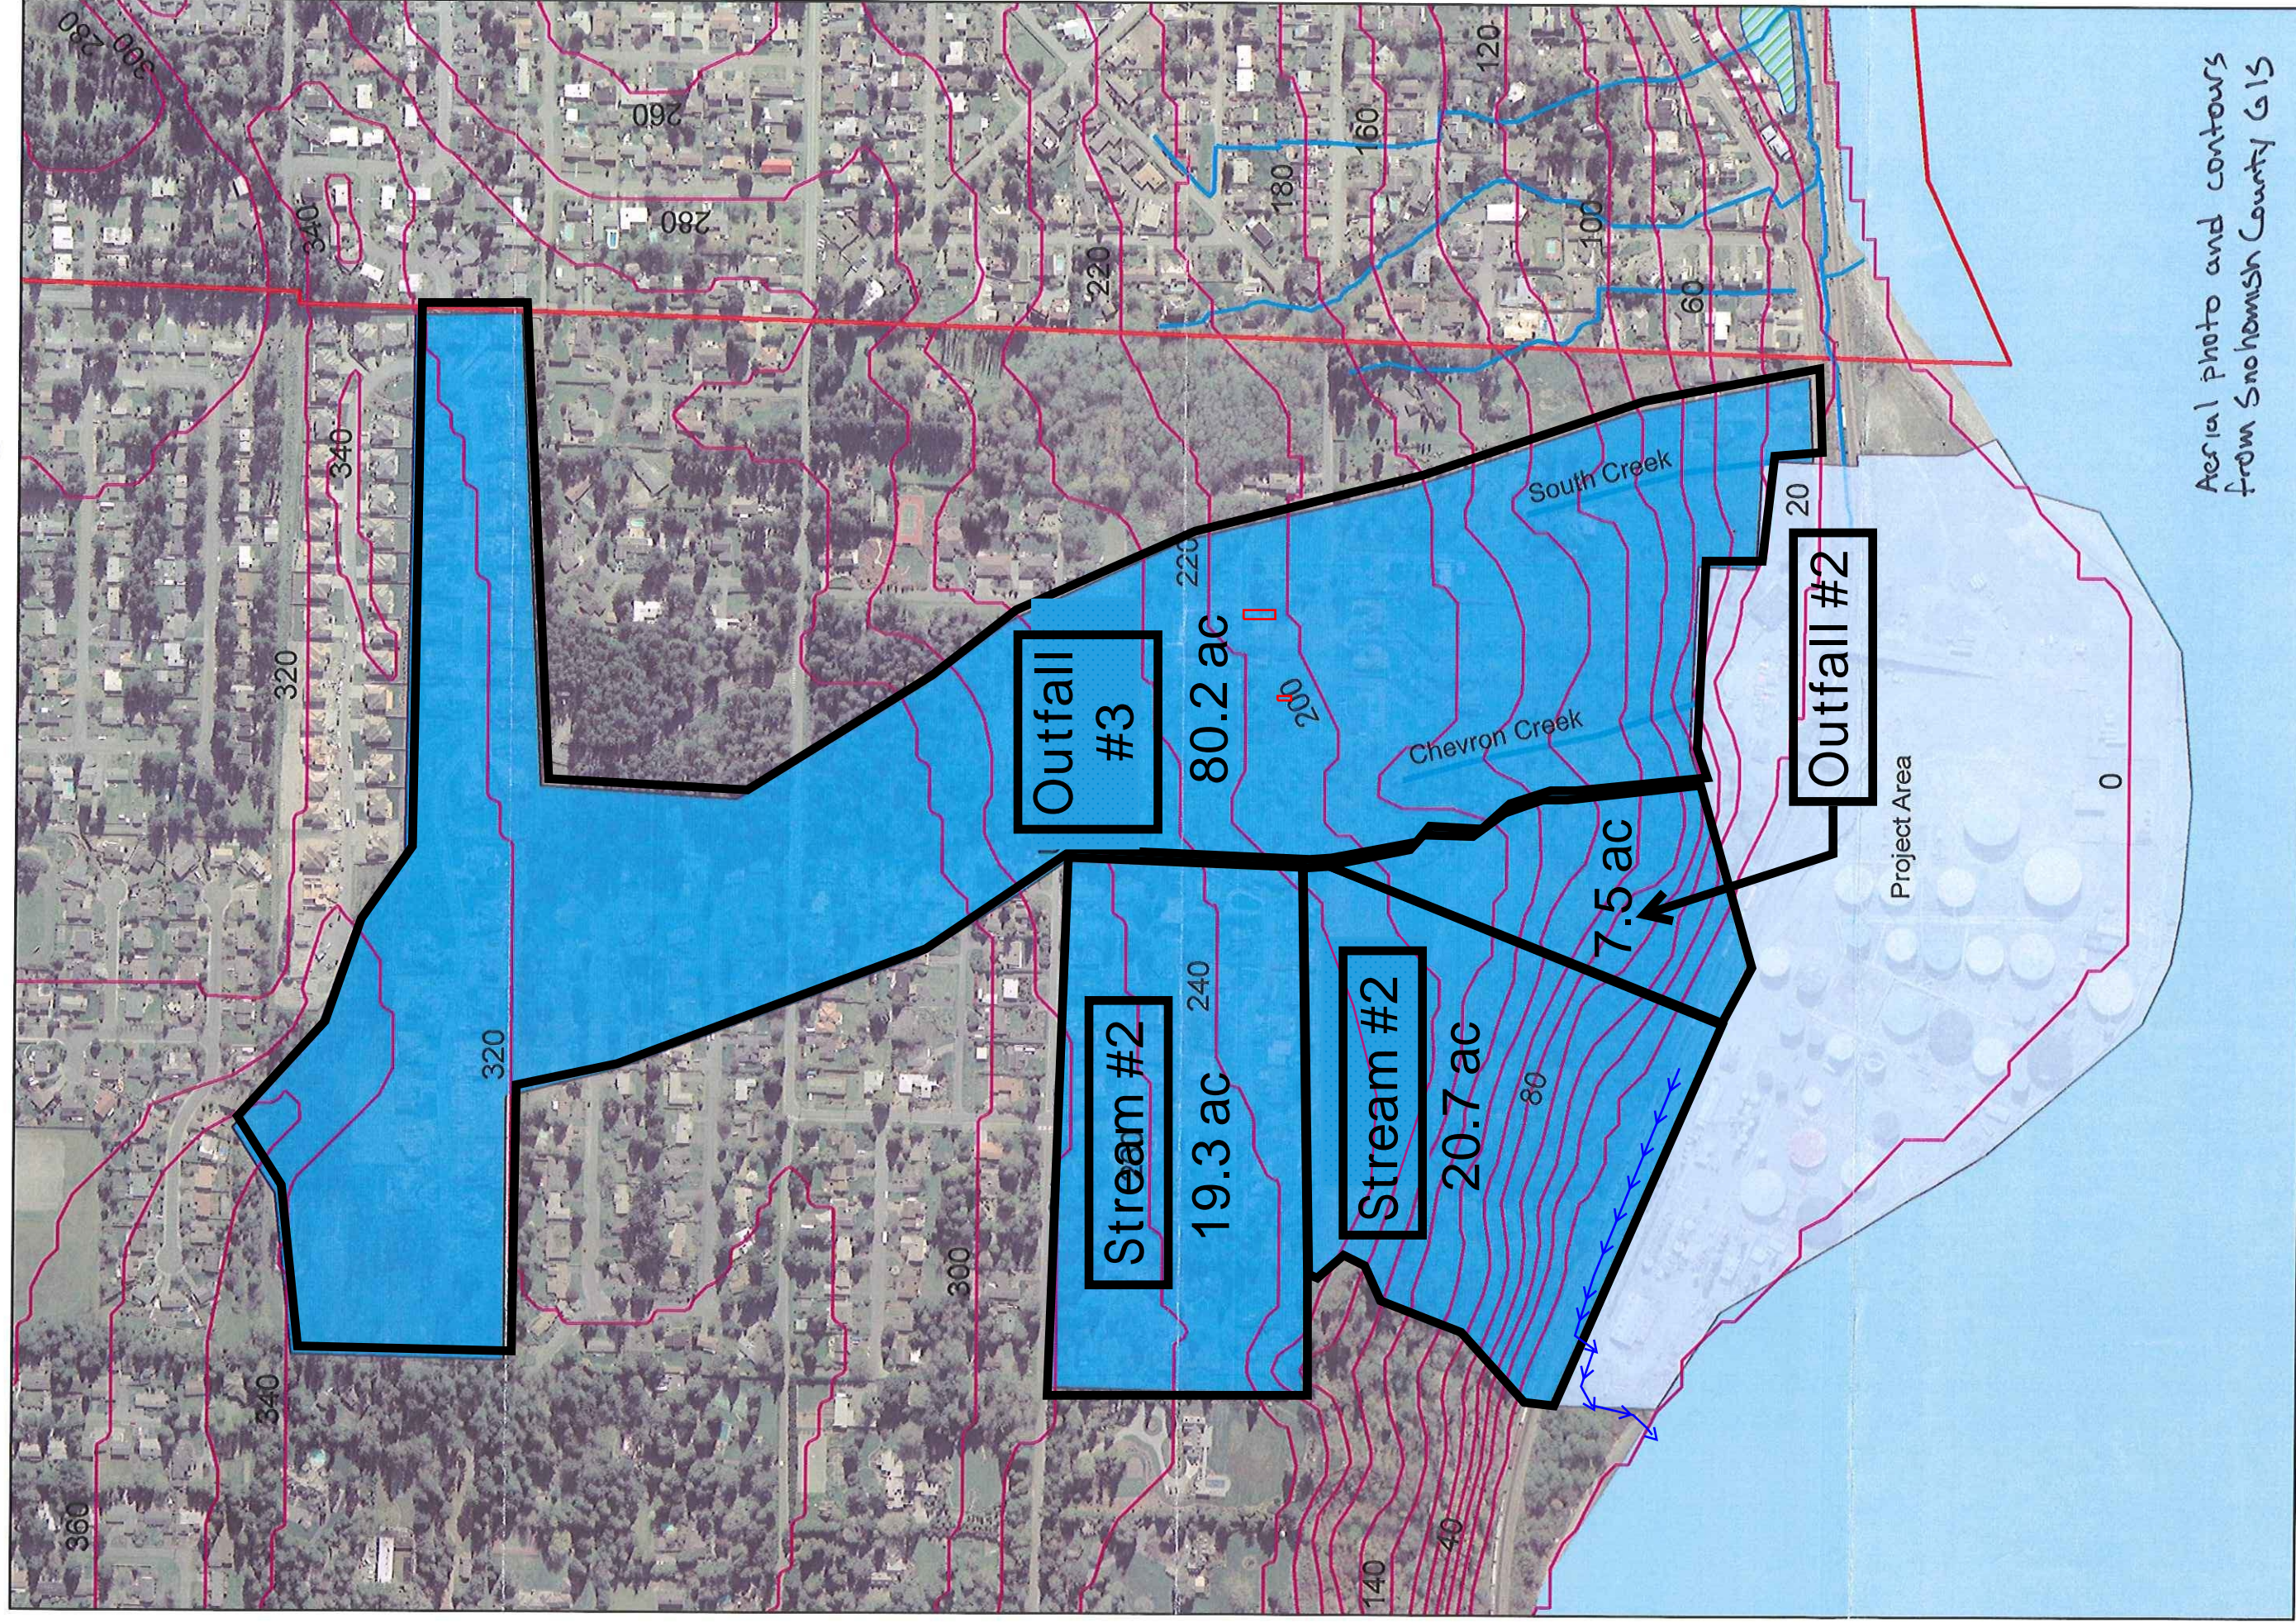
# Point Wells - Upstream Drainage Basins

Aerial photo and contours  
from Snohomish County GIS

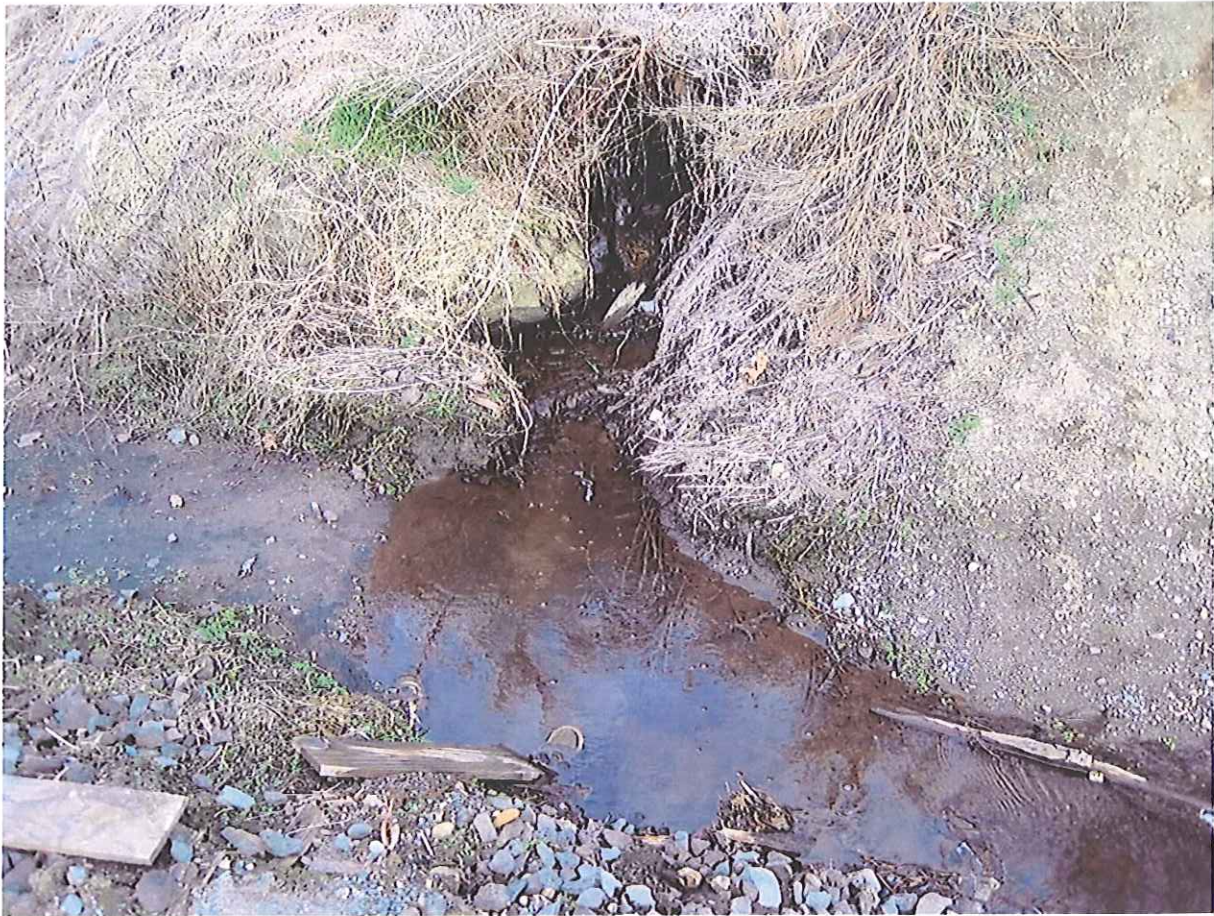
Photo 5. Discharge to east side of BNSF Railroad

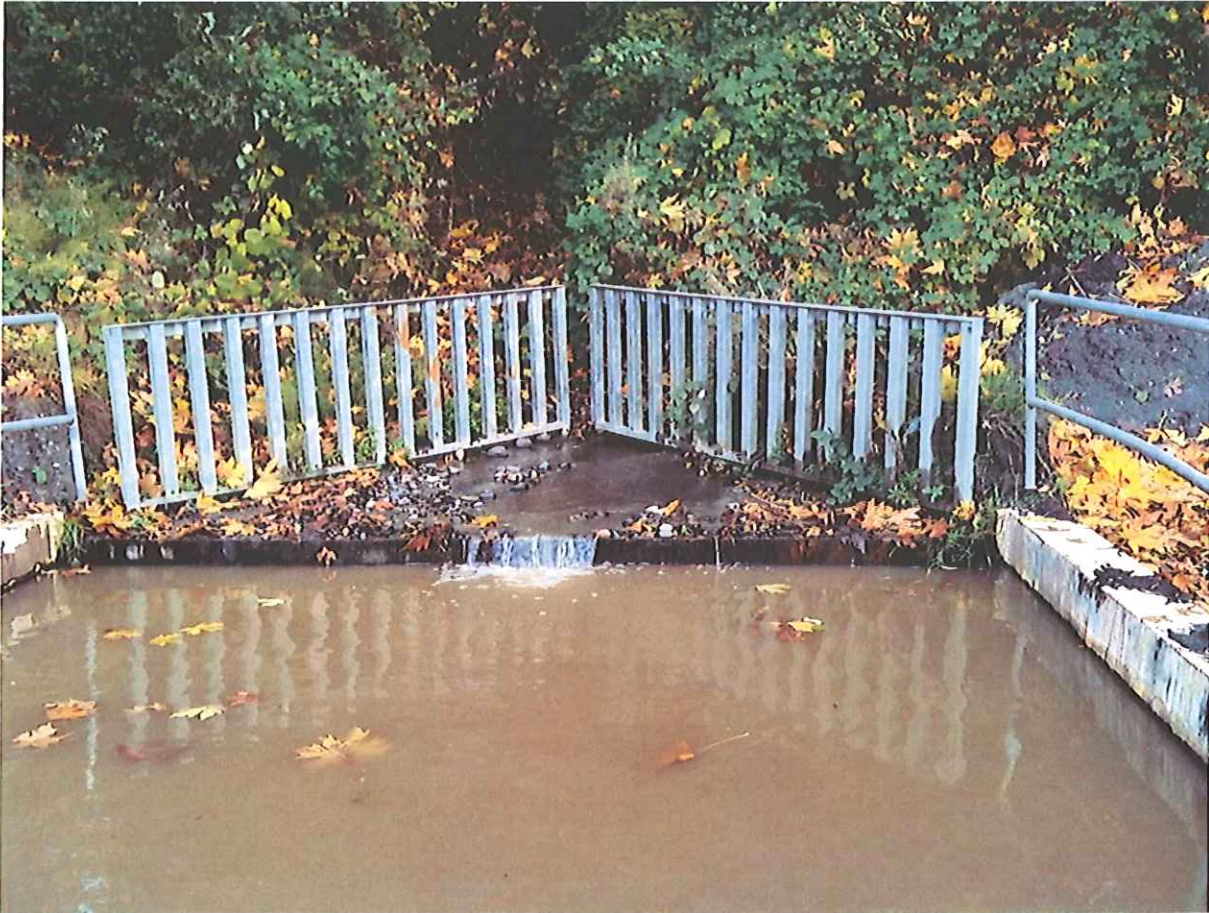
Photo 6. Chevron Creek Sediment Basin prior to Conveyance Pipe

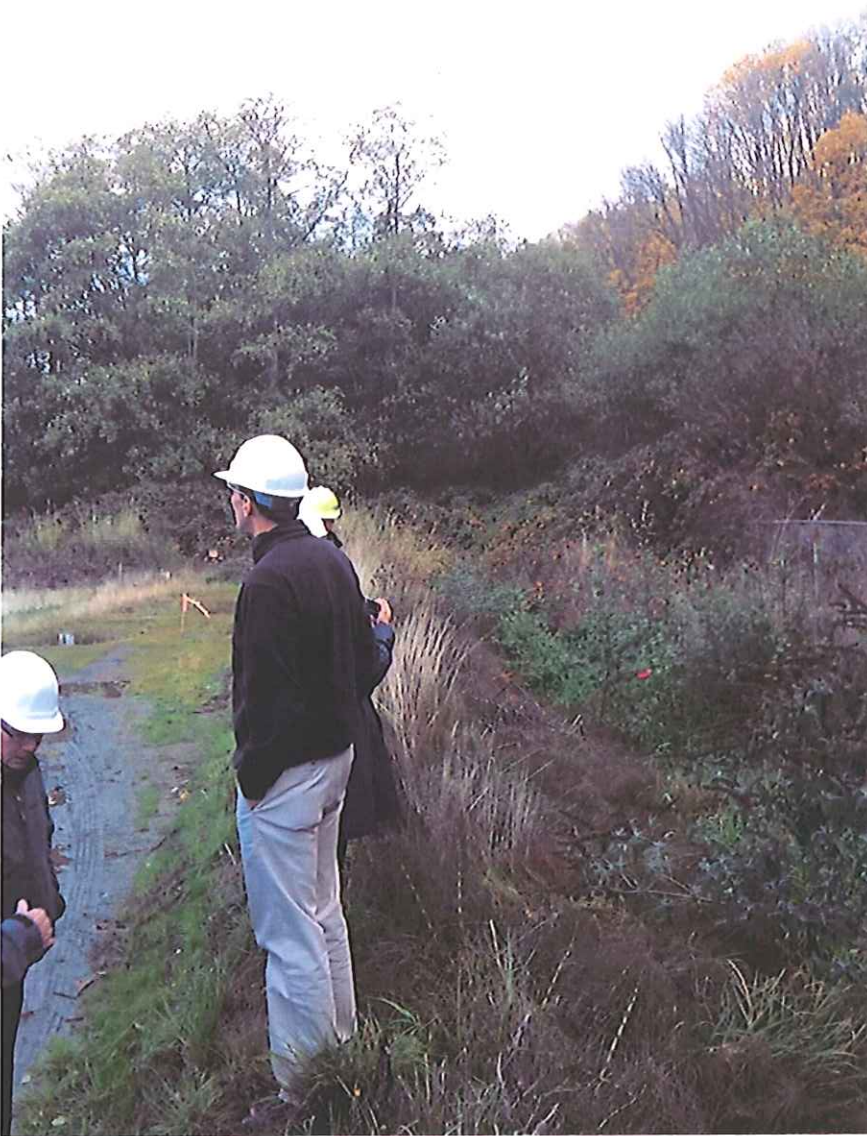
Photo 9. Point Wells northern ditch west side of BNSF Railroad

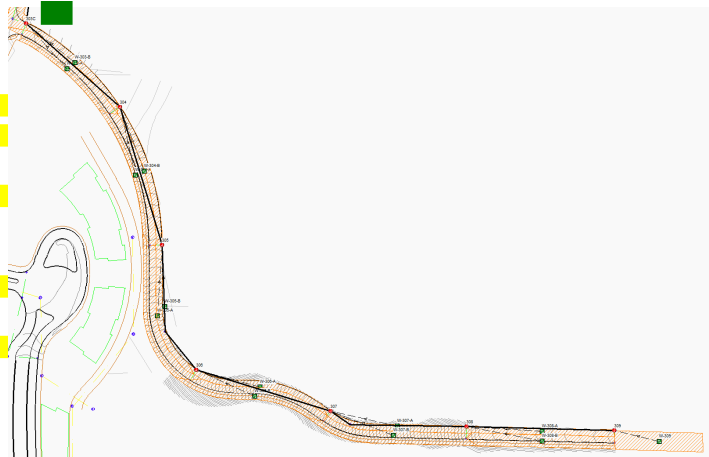
Filterra Bioscape Planter-301

Outfall 1 Basins: W-303 to  
W-309 (see appendix G)

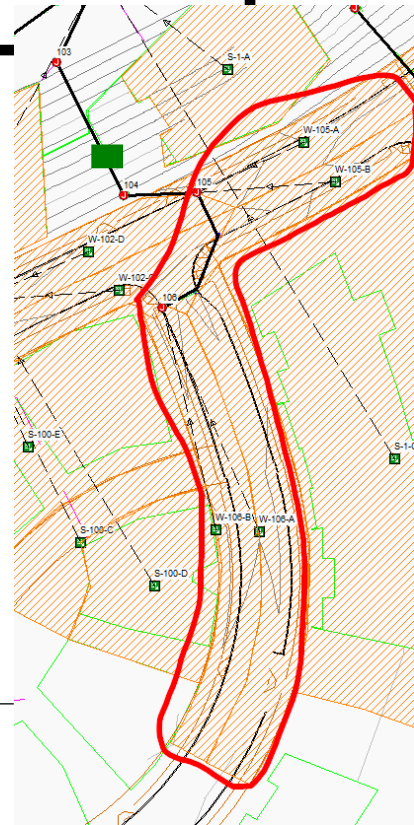
**Filtrerra Vault 302-2**  
**Outfall 1 Basins: W-105 TO W-106**  
**(see appendix G)**

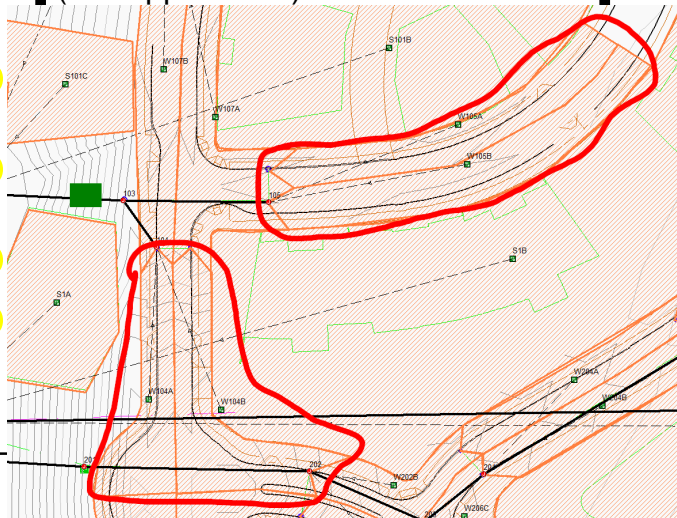
Filterra Vault 302-5  
Outfall 2 Basins: W-104 TO W-105  
(see appendix G)

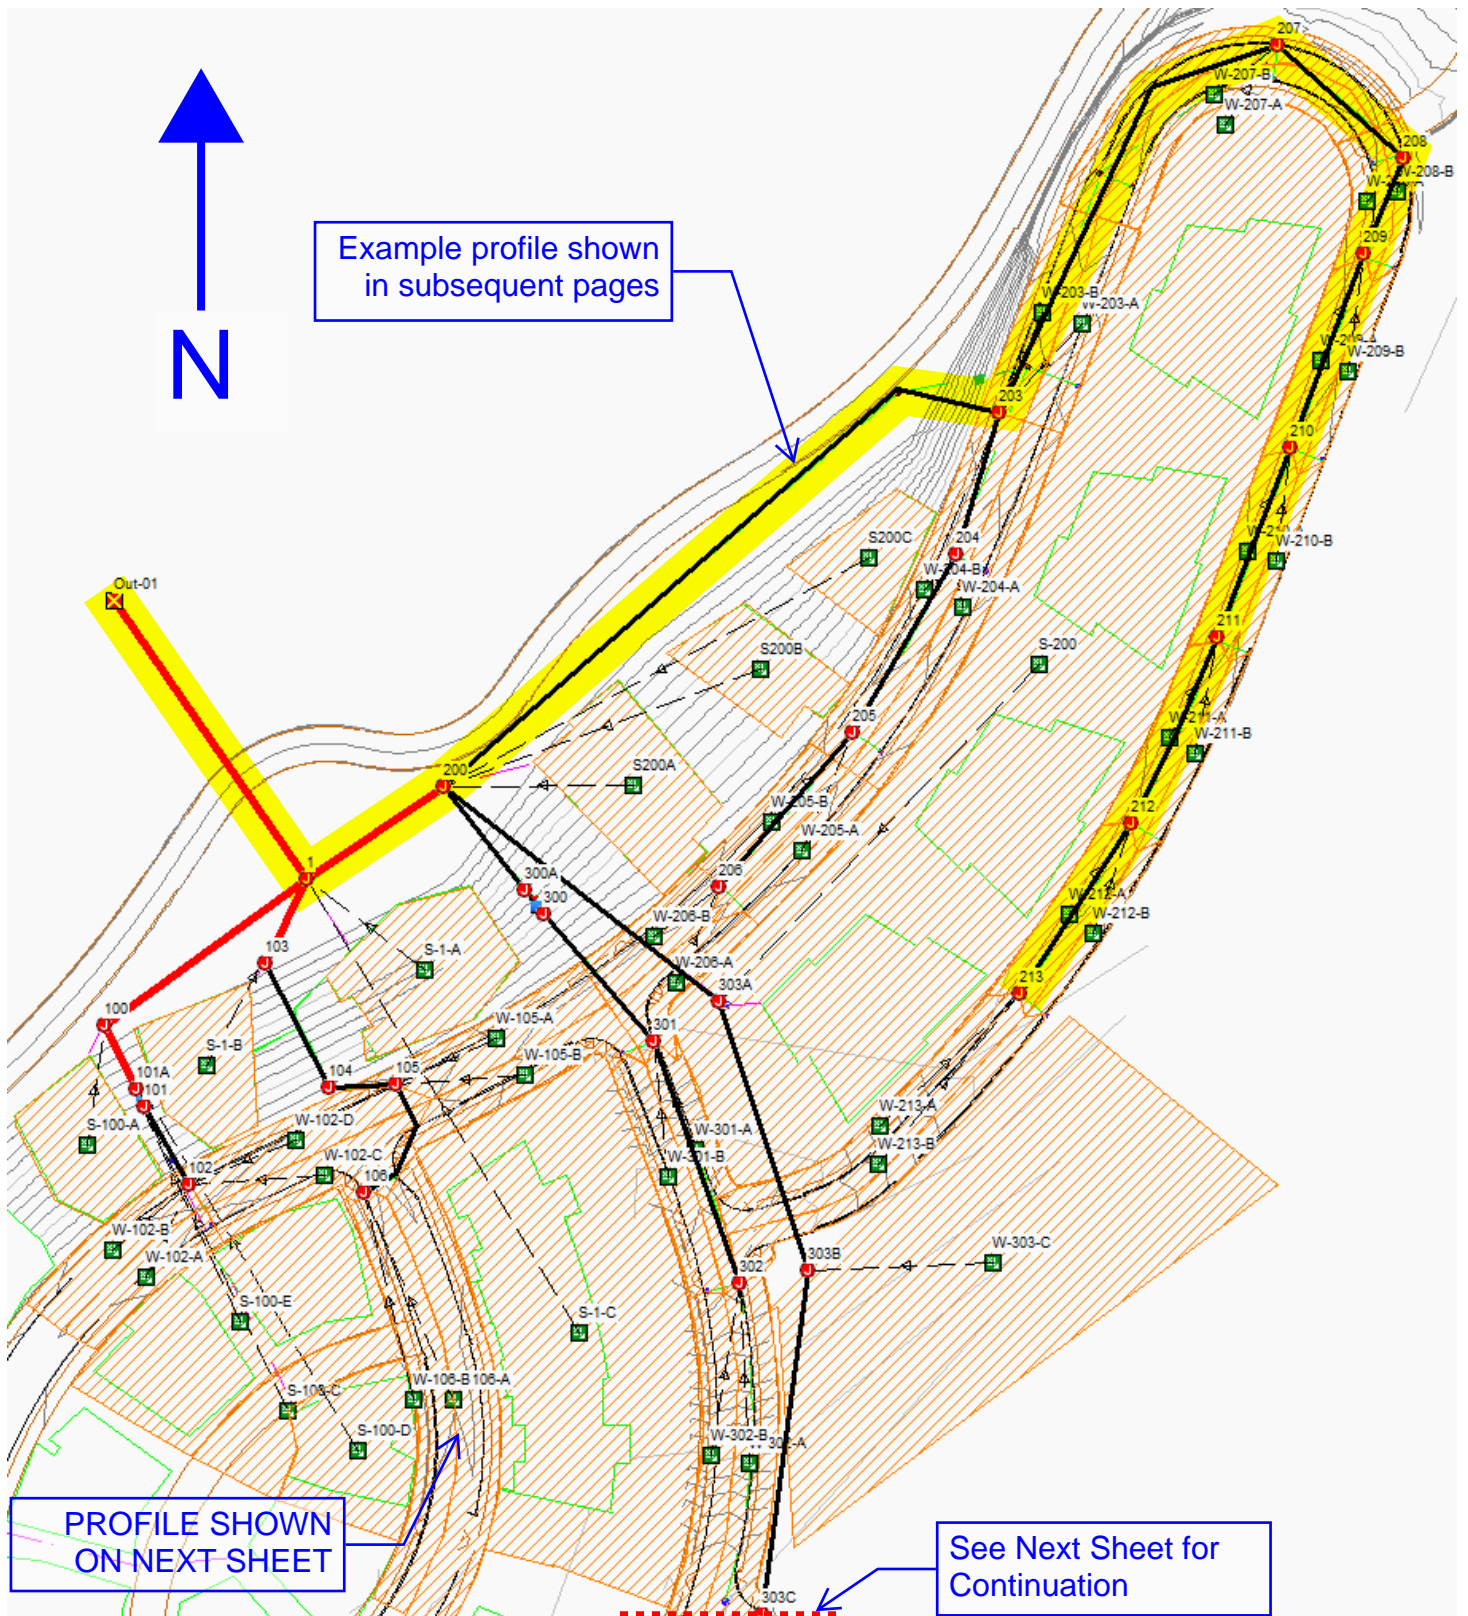
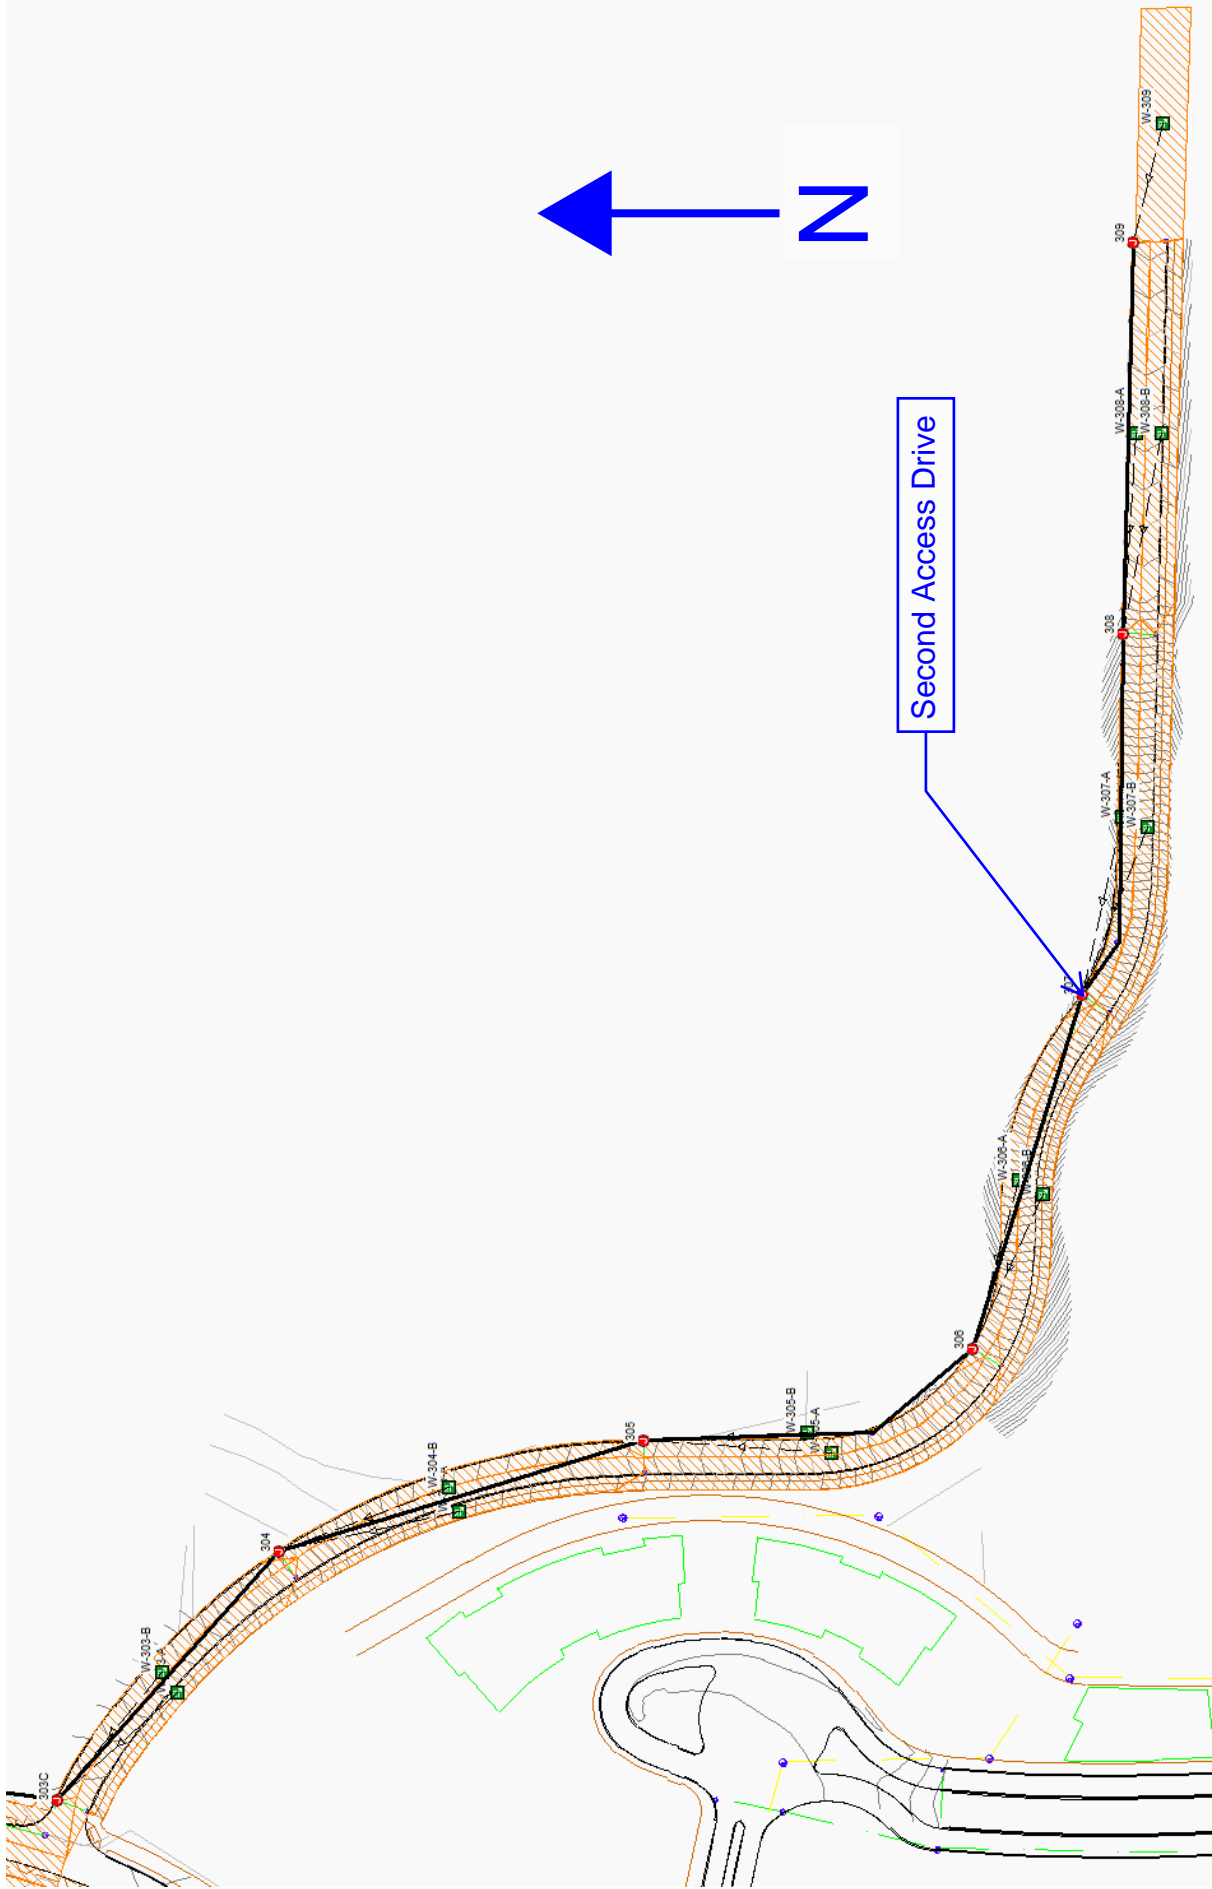
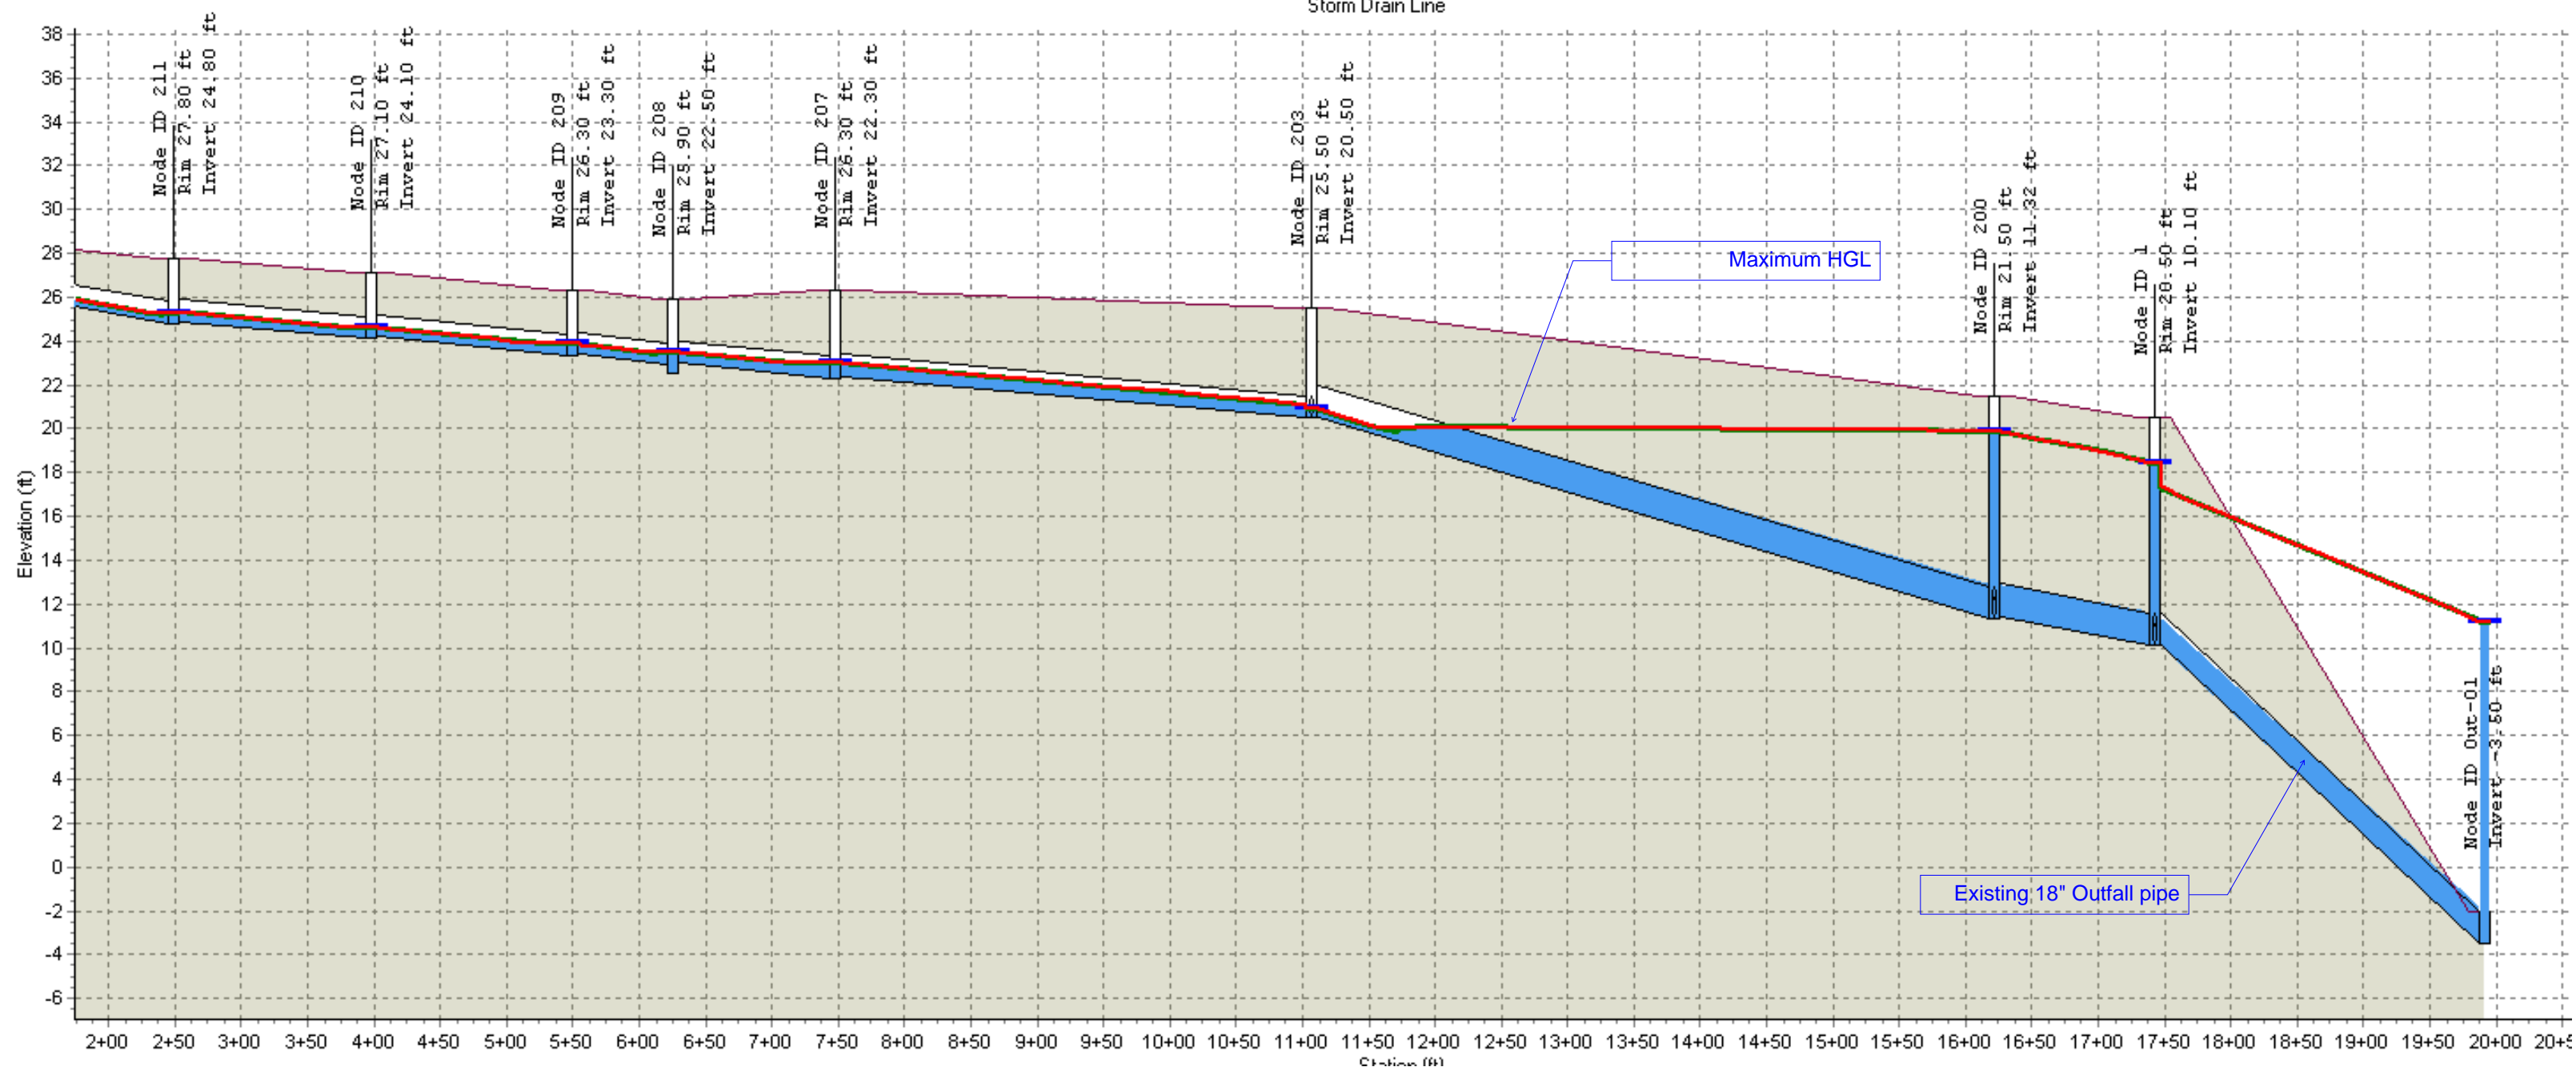
# OUTFALL 1 - HYDRAULIC MODELING SUMMARY

## Profile View

## Storm Drain Line

The proposed storm drain network is sized to convey the 100-year storm. See Appendix G for the hydraulic analysis for outfalls 1 and 2. Routing was modeled using Storm & Sanitary Analysis 2018, using the hydrodynamic calculation method to represent backwater conditions caused by high tides. Outfalls were modeled with a fixed water elevation of 11.17 NAVD. This is a combination of mean higher water level (8.84) with 100 years of sea level rise (+28"). These values were obtained from the Point Wells Redevelopment Coastal Engineering Assessment Draft prepared by Moffatt & Nichol dated April 23, 2018.
